# Bright is the new black—multi-year performance of high-albedo roofs in an urban climate

Reporter: Cheng Di

BJT: 28/10/2016

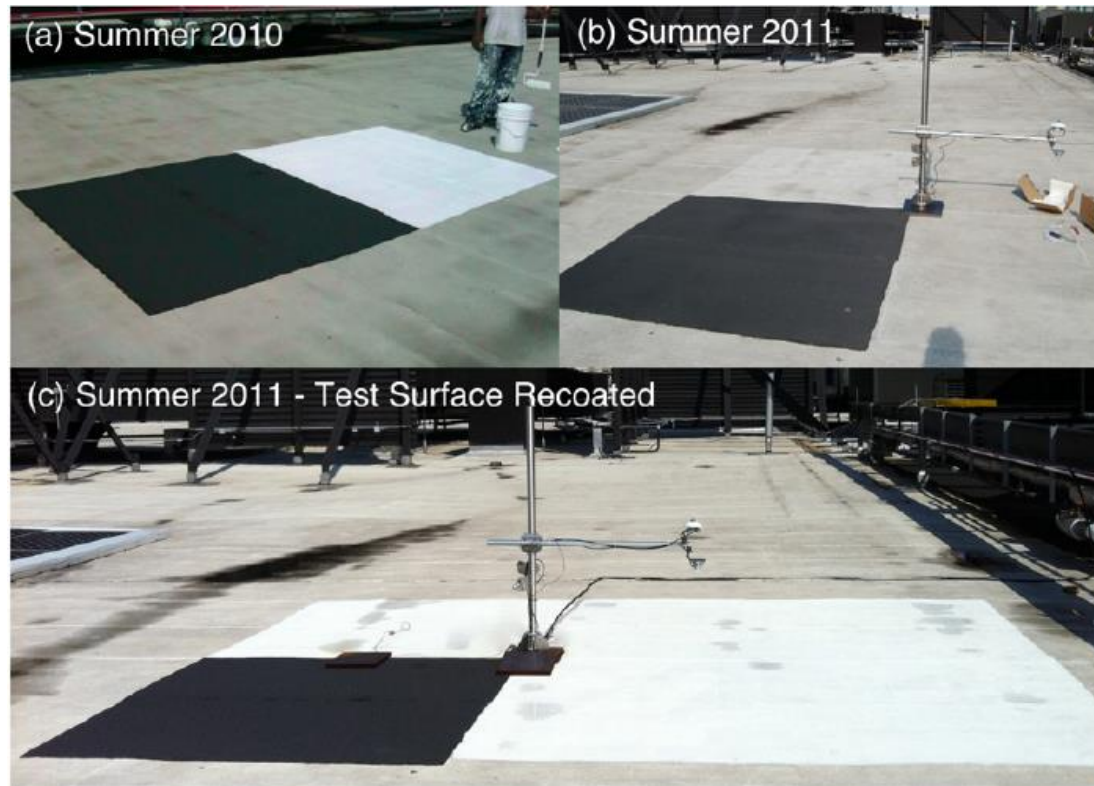
Figure 3. White roof conditions during the summers of 2010 and 2011 showing albedo loss effects over time. The original black membrane was first coated in summer 2009. (a) Surface conditions one year later after a fresh test patch was applied in summer 2010. (b) Surface conditions two years later just before sensor deployment began. (c) Surface conditions at the start of data collection after a second recoating.

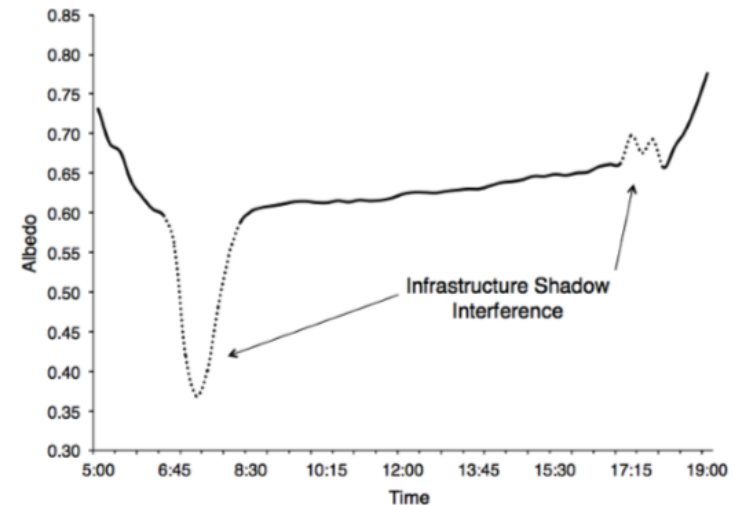
**Figure 5.** Hourly averaged albedo data for the MoMA Queens site during the summer of 2011 showing the change during the daily solar cycle. Dashed lines indicate interference by rooftop infrastructure, which cast shadows on the sensors during sunrise and sunset.

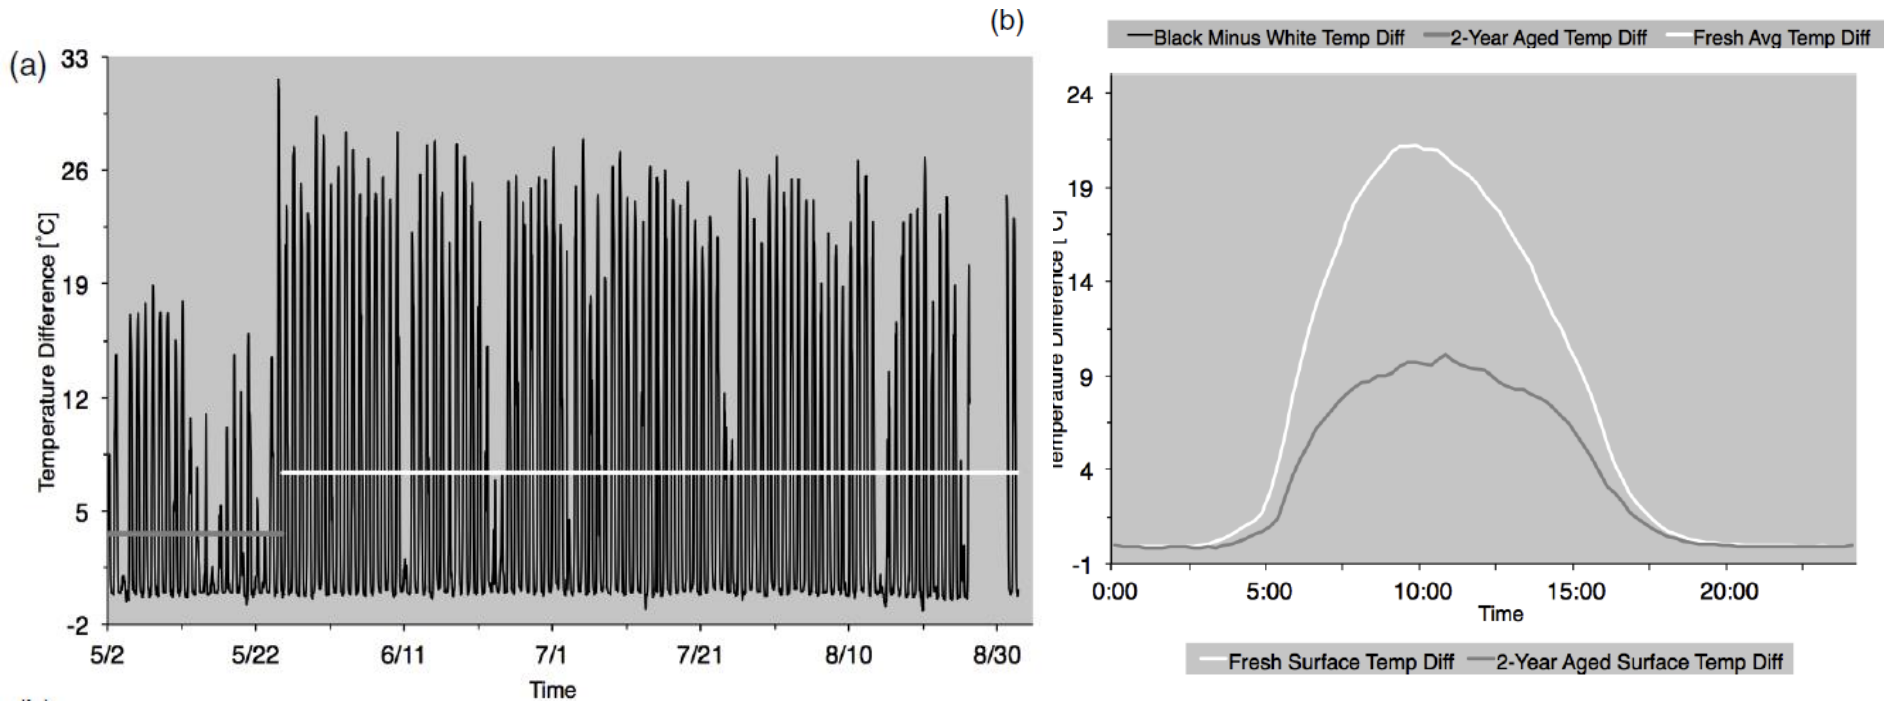
Figure 6. (a) Hourly black minus white temperature differences measured over summer 2011 at the MoMA Queens site. Also shown are the average pre-recoating difference value (horizontal gray line) and post-recoating difference value (horizontal white line). (b) Black minus white surface temperature differences averaged over the diurnal cycle for the fresh coating (white line) and also for the two-year aged surface (gray line) at the MoMA Queens site. The aged surface lost approximately half its temperature control, consistent with an approximately 50% albedo loss.

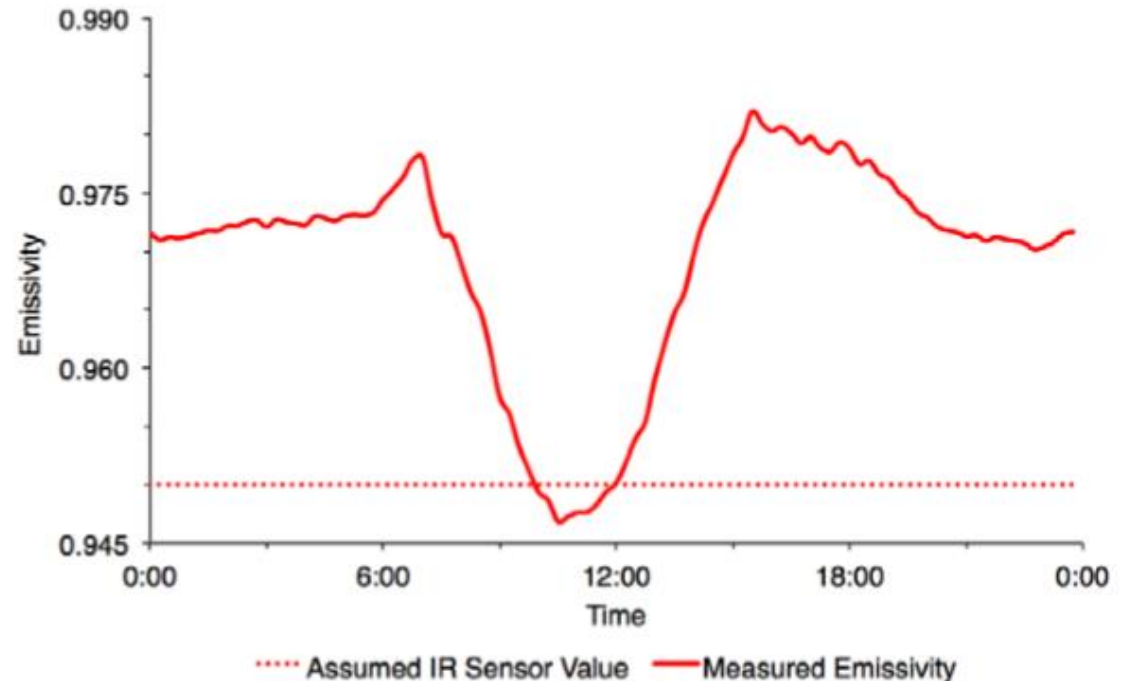
$$\varepsilon_{\text{actual}} = 0.95 \left( \frac{T_{\text{IR}}}{T_{\text{actual}}} \right)^4$$

**Figure 7.** Average hourly emissivity values at the MoMA Queens site, calculated using data for equation (1), over the diurnal cycle are shown by the upper fluctuating line. The constant dashed line is the assumed infrared sensor emissivity of 0.95 that was programmed into the datalogger.

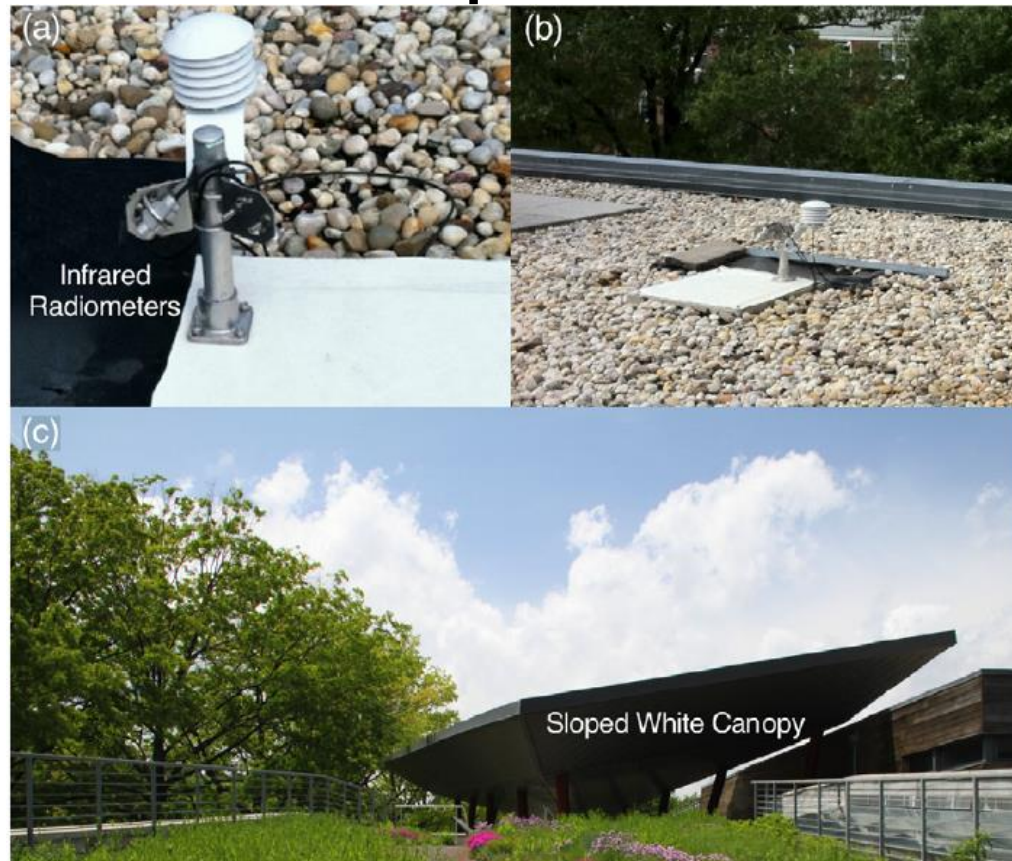
Figure 10. Sensor and test surfaces set up ((a) and (b)) on the Queens Botanical Garden. The building TPO membrane is actually a sloped canopy (c) requiring the use of a small horizontal test membrane.

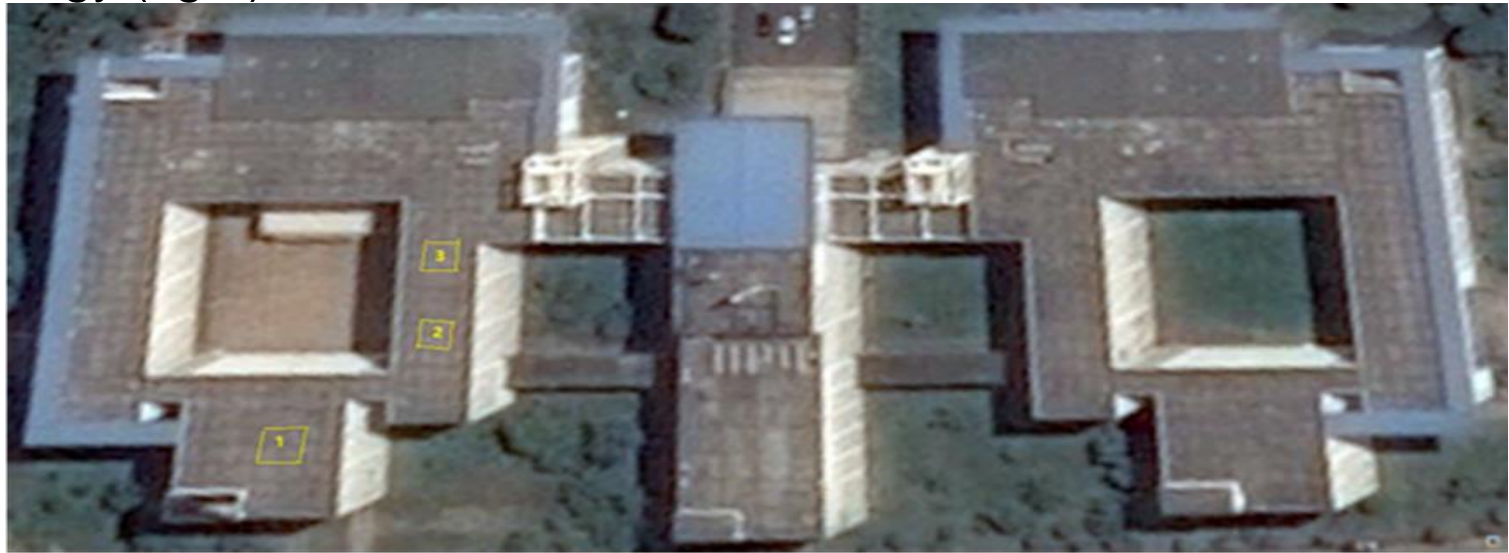
**Figure1.** Experimental Distribution of the Roof of the North Area of Wende building

Wende building's roof in Nanjing University of Information Science and Technology.(fig.1)

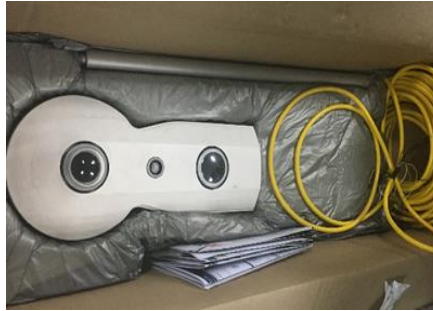
| Equipment name | Number | Model | Picture | Price(RMB) |
|---|---|---|---|---|
| CNR4 Net Radiometer<br>Pt-100 temperature sensor and heater | 3<br>(we've got 2) | CNR4 | | 59,475 |

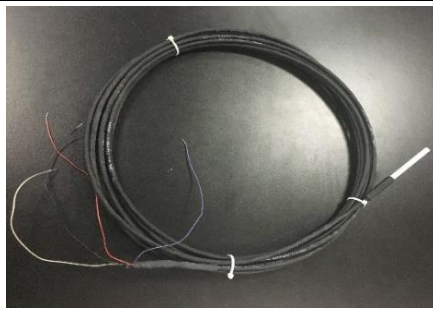
| Equipment name | Number | Model | Picture | Price(RMB) |
|---|---|---|---|---|
| Apogee20 Infrared Radiometer | 6<br>(we've got 9) | T109 | | 6,838 |

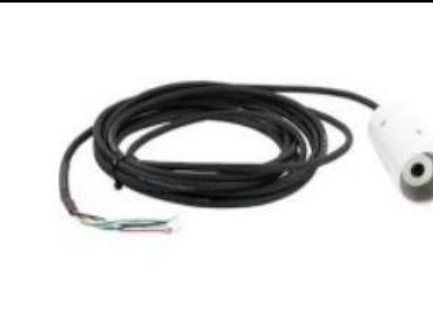
| Equipment name | Number | Model | Picture | Price(RMB) |
|---|---|---|---|---|
| 109-L temperature probe(-50°C to 70°C) | 3 or 6<br>(None yet) | SI-111 | | 2,760 |

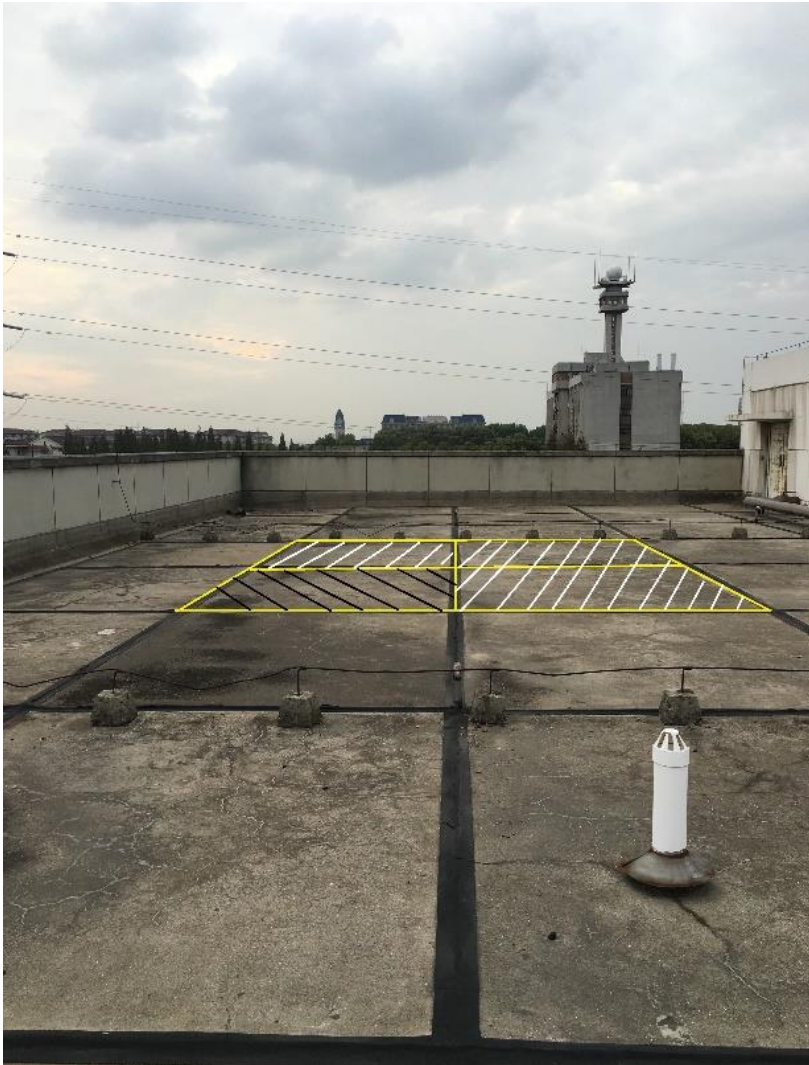
Figure2.Test area 1(acrylic)

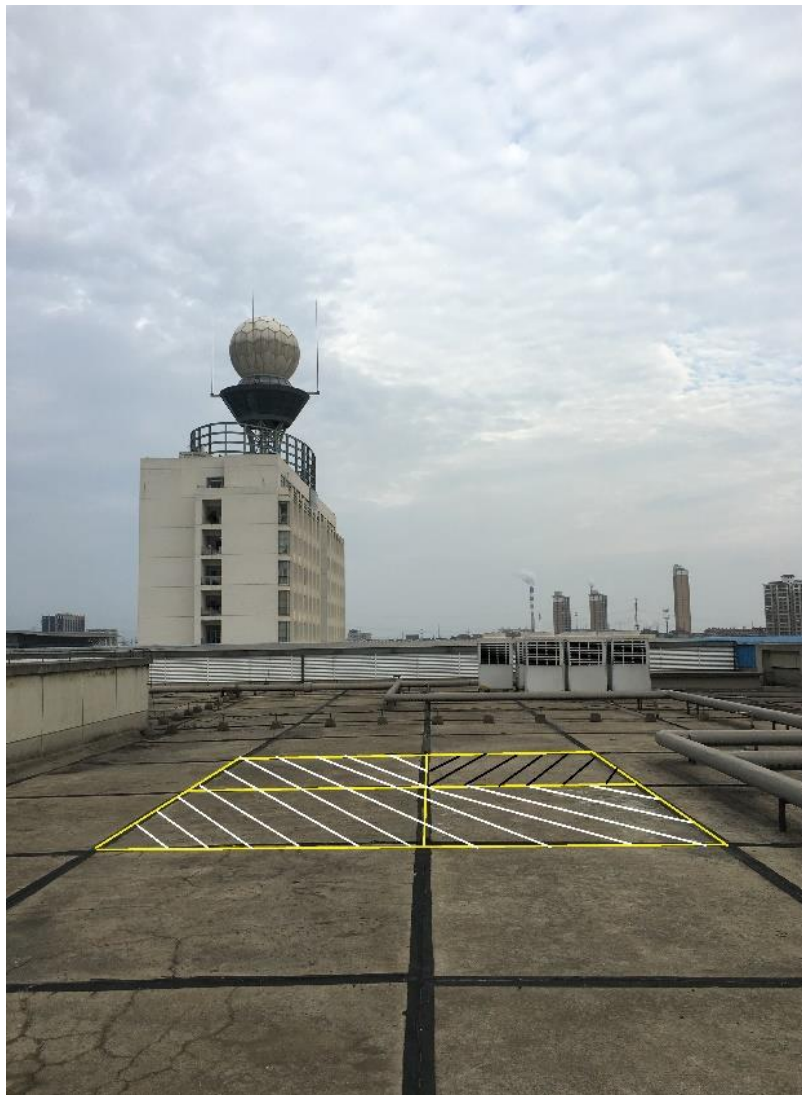
Figure4. Test area 3 (aluminum foil)

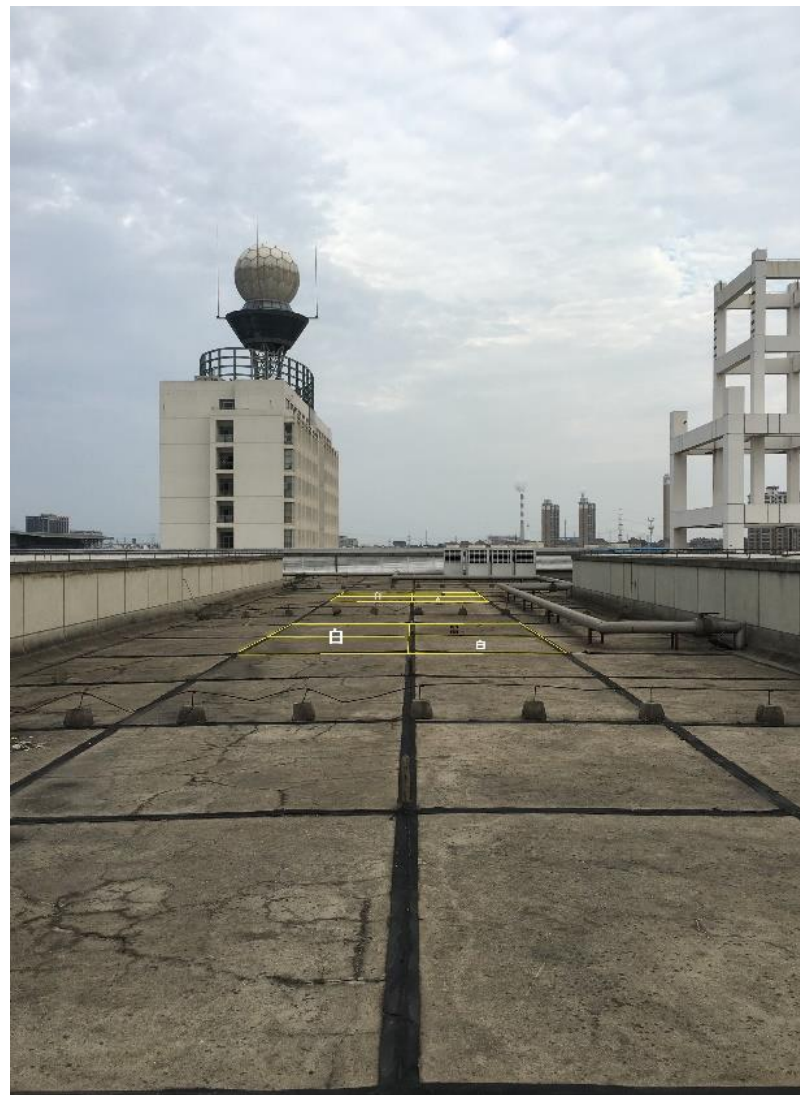
Figure4. Landscape of Test area 2、3
